Ground-Recorded Sonic Boom Signatures of F-18 Aircraft in Formation Flight

Catherine M. Bahm and Edward A. Haering, Jr.

September 1995

1. AGENCY USE ONLY (Leave blank)	2. REPORT DATE September 1995	3. REPORT TYPE AND DATES COVERED Technical Memorandum	
4. TITLE AND SUBTITLE Ground-Recorded Sonic Boom Signatures of F-18 Aircraft in Formation Flight		5. FUNDING NUMBERS WU 537-03-21

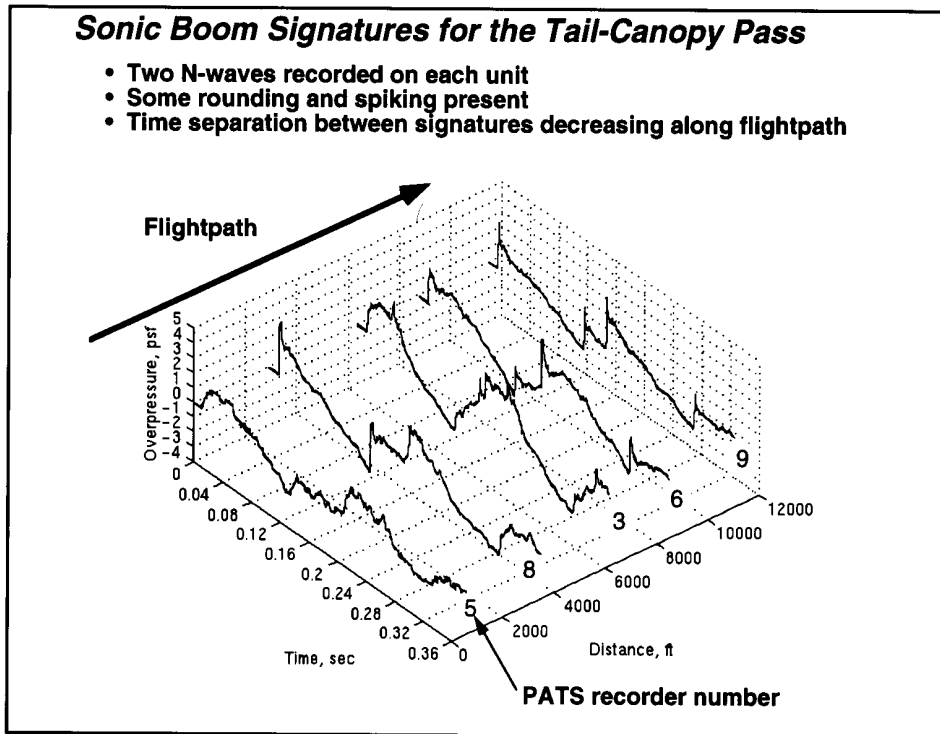
Slide 7a shows the sonic booms that were recorded in the tail-canopy pass. This plot shows the overpressure as a function of time for each of the sonic boom signatures and as a function of distance from the first PATS recorder. The signature at zero distance was the first signature recorded. The number by each signature denotes the PATS number. Slides 7b through 7f show individual plots of each of the tail-canopy signatures. Slide 7b shows the signature recorded by the first recorder, PATS 5, which has the lowest resolution, 0.10 psf/bit. Slides 7c, 7d, 7e, and 7f are the signatures recorded by PATS 8, 3, 6, and 9, respectively.

It was hoped that a modified N-wave would be recorded on the ground; however, the signatures recorded for the tail-canopy pass contained two, separated N-waves. One reason these sonic boom signatures did not combine might be that the lower F-18 was too far aft because of the engine noise position mentioned earlier. In addition, because the lower F-18 aircraft was positioned underneath the upper F-18, the shock structure of the two aircraft would only be combined in a small corridor directly below the aircraft and possibly not 3 miles laterally off track where the recorders were located. Lastly, the time separation between the two signatures appears to decrease with each recording, possibly because the lower F-18 aircraft was creeping forward relative to the upper F-18 aircraft.

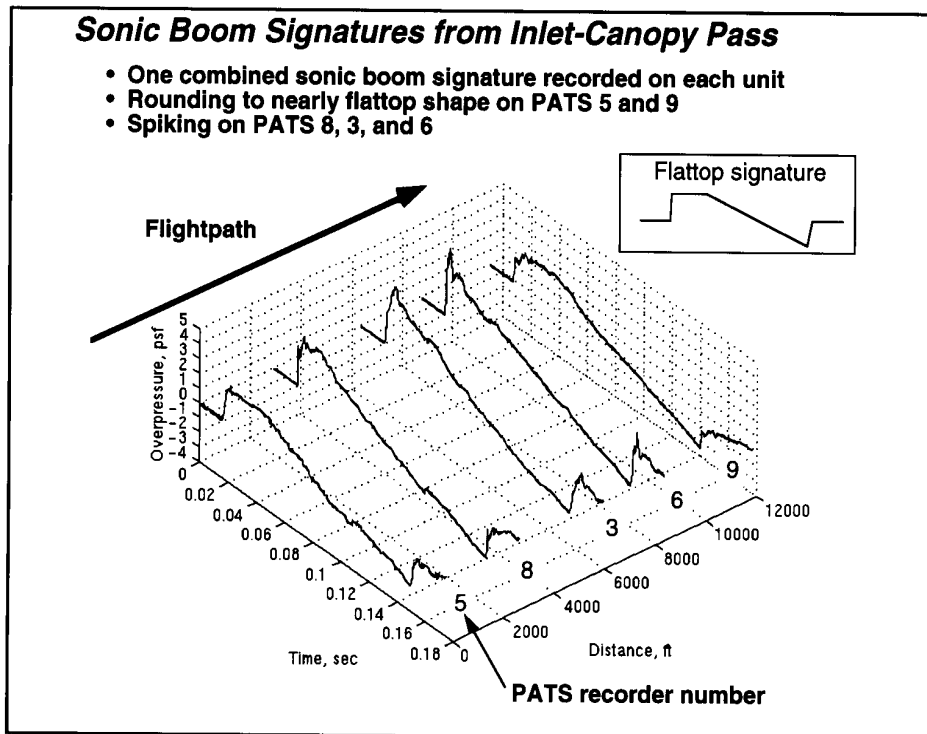
Slide 8a

The sonic booms recorded during the inlet-canopy pass can be seen in slide 8a. Individual plots of each of the inlet-canopy signatures are shown in slides 8b through 8f. Slides 8a-8f show that the positioning of the F-18 aircraft allowed the shockwaves from the two aircraft to coalesce and generate a single sonic boom signature on the ground. Slides 8b and 8f show rounded signatures that approximate a flattop shape.

Slides 7a through 8f show that some of the signatures contain a peaked, or spiked, overpressure, while other signatures are rounded. The variation between the signatures in each of the passes probably results from the atmospheric conditions that the shockwaves passed through. Certain atmospheric conditions can cause spiking and rounding of the N-wave and can also increase the rise time to maximum overpressure (Likens and Blackstock, 1992; and Garrick and Maglieri, 1968).

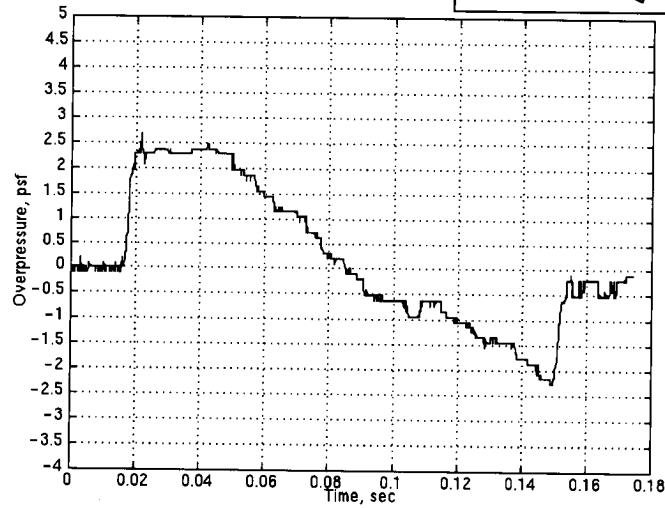
Slide 8b

Inlet-Canopy Pass, PATS 5

- One sonic boom signature
- Rounding to nearly flattop shape

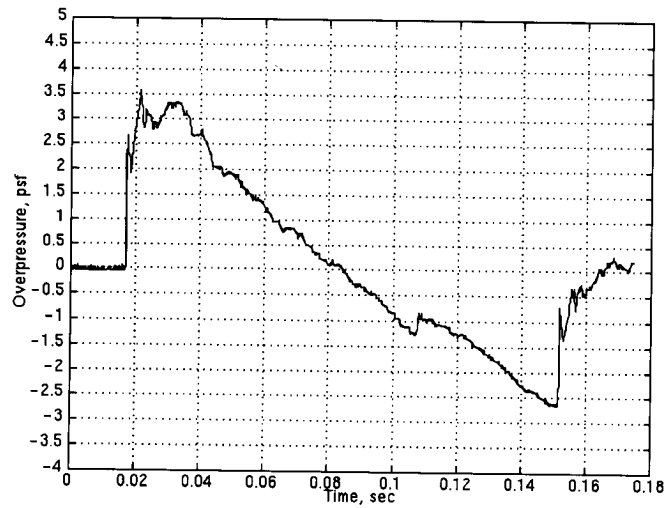
Slide 8c

Inlet-Canopy Pass, PATS 8

- One sonic boom signature
- Spiking
- Possibly not completely combined shocks

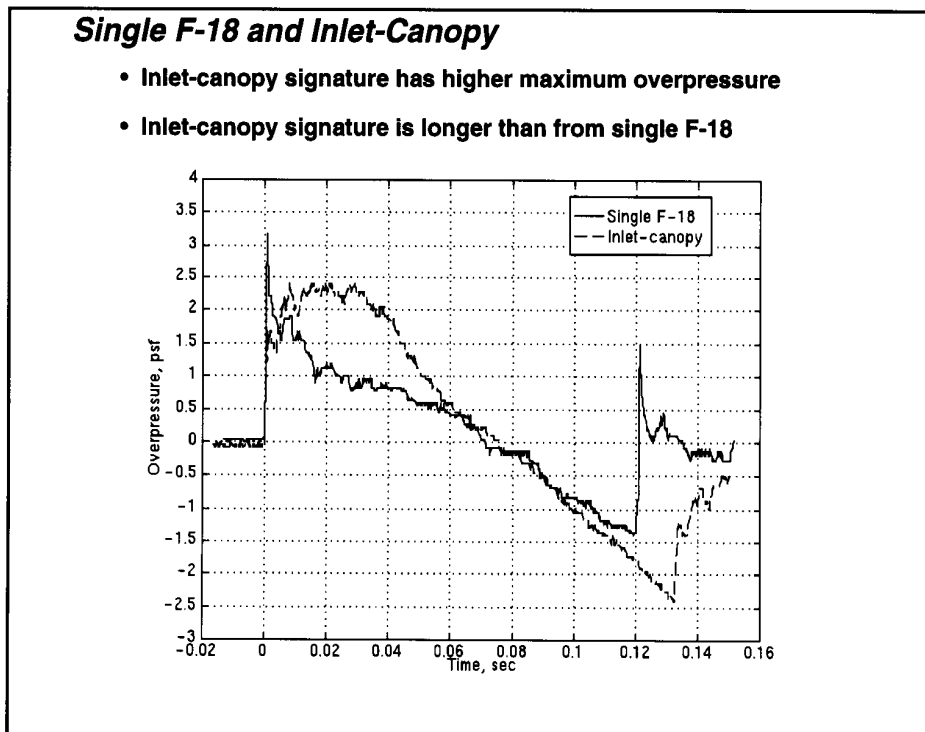
Slide 9

Because two N-waves were recorded during the tail-canopy pass, it has been assumed that the longitudinal separation between the aircraft was great enough that no interaction between the shockwaves was measured at the sonic boom recorders. Under that assumption, a comparison was made between the first N-wave of the tail-canopy pass (one F-18 aircraft) and the single N-wave recorded during the inlet-canopy pass (two F-18 aircraft) of the same recorder (PATS 9 in slide 9). The maximum overpressure of the signature from the inlet-canopy pass is greater than that of the single F-18 signature if the spiking is ignored. There are two reasons for this occurrence. First, coalescing of the shocks from both aircraft reinforces the maximum overpressure. Second, the inlet-canopy pass occurred directly over the sonic boom recorders, while the tail-canopy pass occurred at a 3-mile lateral offset (slide 6). Note also that the length of the inlet-canopy pass signature is longer than that of the single F-18 aircraft. This result was expected because the length of the signature depends on the length of the aircraft.

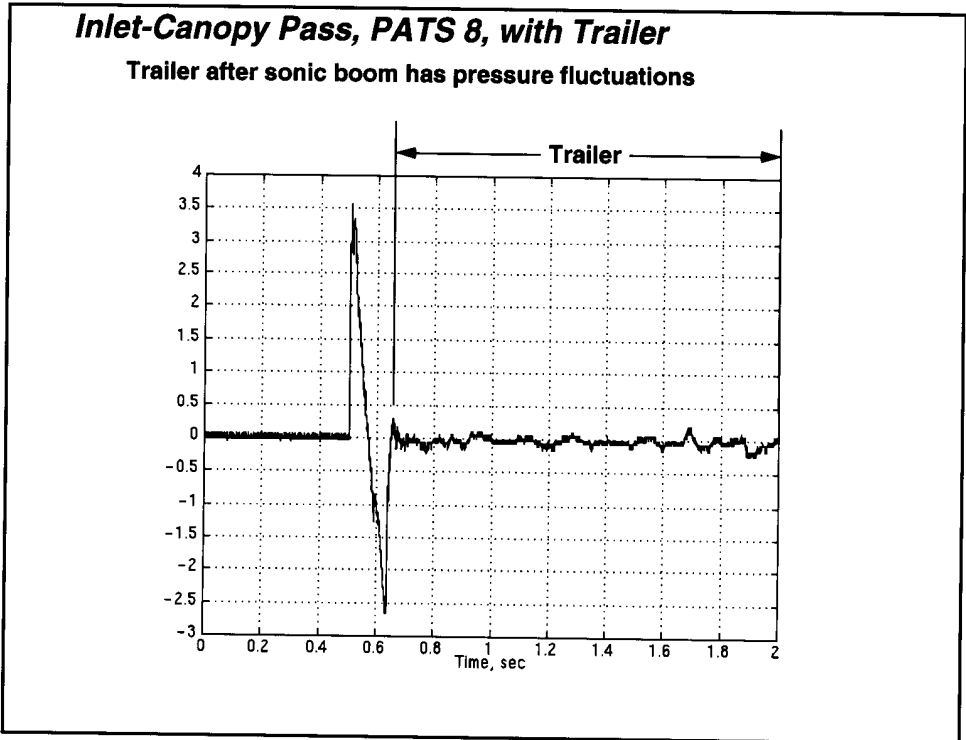
Because the PATS records 2 sec of data and a typical sonic boom signature is usually less than 0.2 sec long, there is additional data (or a trailer) after the signature. Slide 10 shows the signature and trailer recorded by PATS 8 during the inlet-canopy pass of the F-18 aircraft. After the sonic boom signature, the pressure normally returns to ambient.

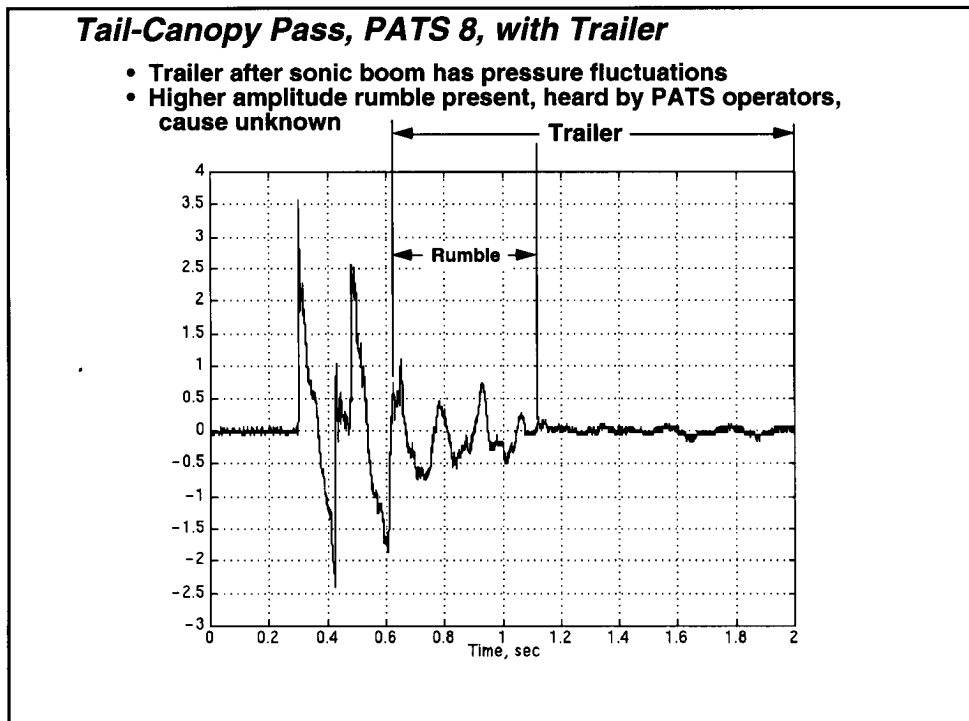
Slide 11 shows the entire 2 sec of data recorded by PATS 8 during the tail-canopy pass. This slide shows the two N-waves followed by high-amplitude rumble. This rumble was recorded on all recorders during the tail-canopy pass and was not recorded by any of the recorders during the inlet-canopy pass. The cause of this rumble is unknown. Maneuvering of aircraft may cause U-shaped waves after an N-wave, but these aircraft were just as steady on the tail-canopy pass as they were on the inlet-canopy pass. Additionally, a study has shown that "porpoising" an airplane with normal acceleration variations as great as ± 0.5 times gravity will not affect ground signatures (Garrick and Maglieri, 1968). One cause of the rumble may be atmospheric effects that could have resulted in a reflected shock. This atmospheric effect is unlikely because the atmosphere differed over the 2-mile length of the ground array enough to affect each signature differently with rounding and spiking. Yet, all the PATS recorded the rumble on the tail-canopy pass.

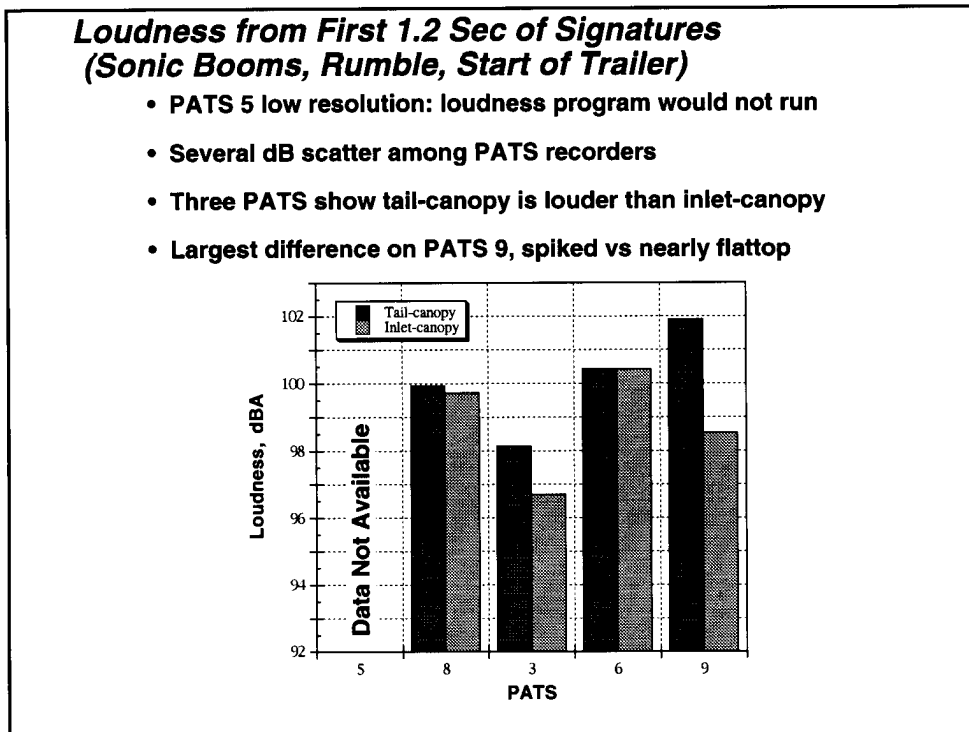
Slide 12 shows the A-weighted loudness for the first 1.2 sec for both passes, which includes both aircraft signatures from the tail-canopy pass. Equal time history segments of 1.2 sec were used for these loudness calculations, which eliminated most of the trailer. Note that the loudness program would not run using data from PATS 5, possibly because of the low resolution of this recorder.

The loudness for a given pass varied by several decibels among the recorders. The tail-canopy pass was as loud or louder than the inlet-canopy pass for all four recorders even though the inlet-canopy pass flight track was closer to the PATS array. The largest difference was seen on PATS 9 which has spiking on the tail-canopy pass and a nearly flattop signature on the inlet-canopy pass.

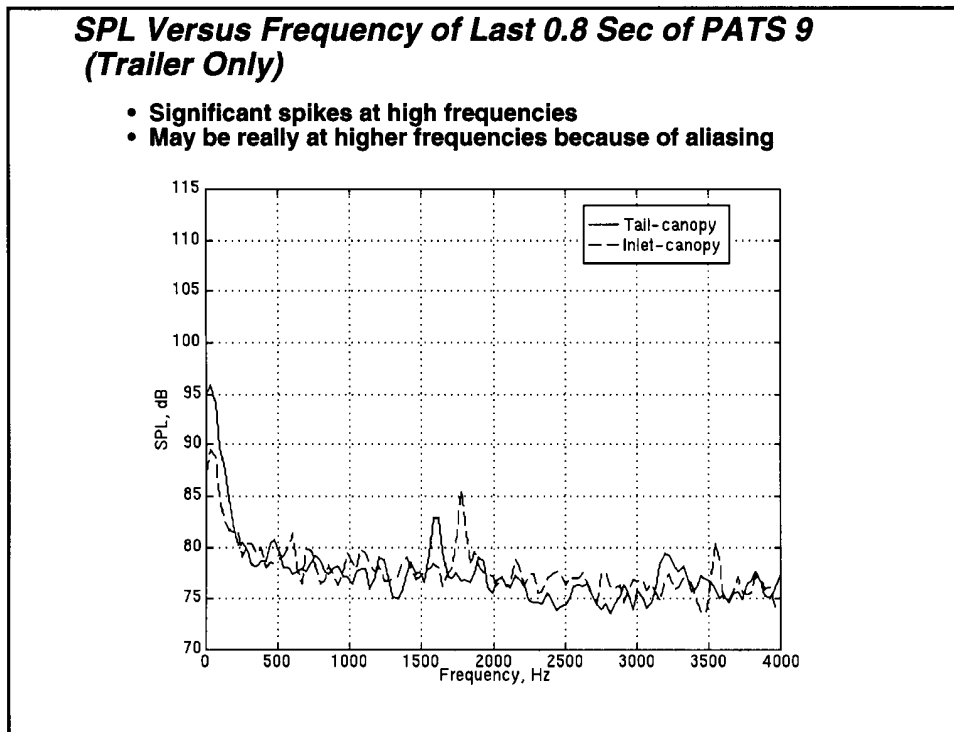
Slide 14 shows high-frequency spikes for the last 0.8 sec of PATS 9 data for both passes. These data contain neither the sonic boom signature nor the rumble from the tail-canopy pass, so high-frequency content was not expected; however, the PATS operators in the field noted that the aircraft engines were quite loud immediately after the sonic booms were heard. This engine noise may be the source for the high-frequency spikes in slide 14 and would be amplified by the A weighting.

Slide 15 shows SPL as a function of frequency for a typical jet turbine engine (a Rolls-Royce engine). Spikes occur in the range from 1000 to 4800 Hz (Bushell, 1976)*. These high frequency spikes in slides 13, 14, and 15 suggests that high-frequency energy in the trailer of the sonic boom signature could be caused by the aircraft engine.

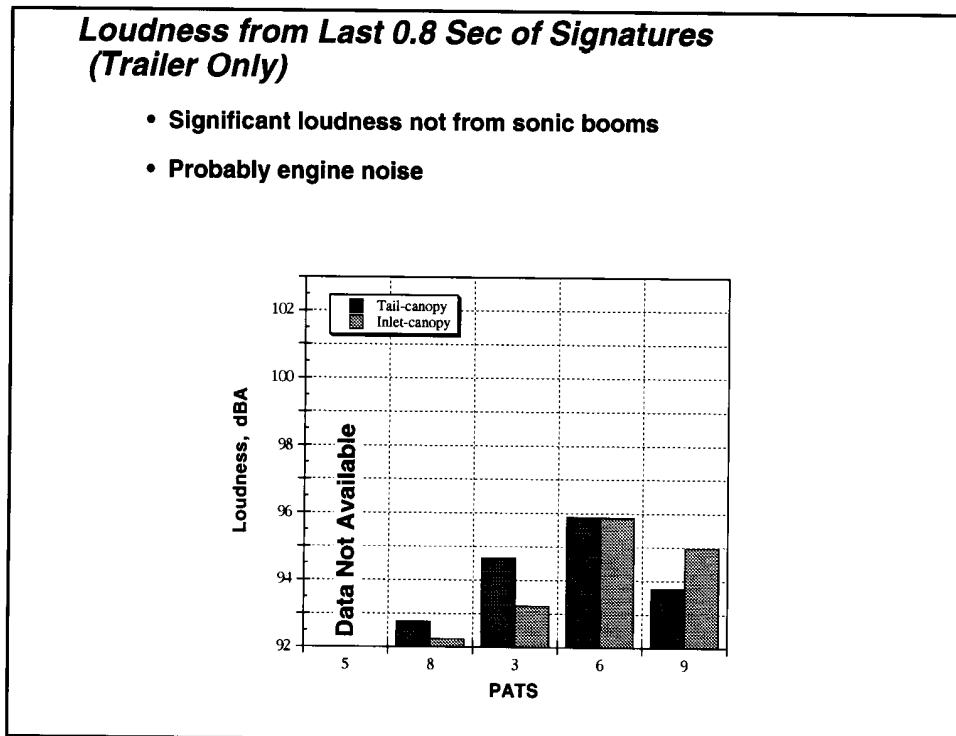
Slide 16

Lastly, the loudness of the last 0.8 sec of data from each sonic boom recorder was calculated (slide 16). Even though no sonic boom signature or rumble was part of the data analyzed, there was still 92 to 96 dBA of loudness, probably from the aircraft engines. Even though sonic booms may significantly startle people and animals, the trailer loudness apart from the sonic boom may be still quite annoying. In future flight experiments measuring sonic boom loudness, care should be taken to separate the loudness of the sonic boom from that of the trailer.
